Subject: Department of Natural Resources Washington Geological Survey,
School Seismic Safety Assessment Project, Contract No. AE 410 -
Seismic Evaluation for **Ocean Beach School District**

School Buildings Evaluated in the Ocean Beach School District

Ocean Beach, Ilwaco (Hilltop) Middle School, Auditorium

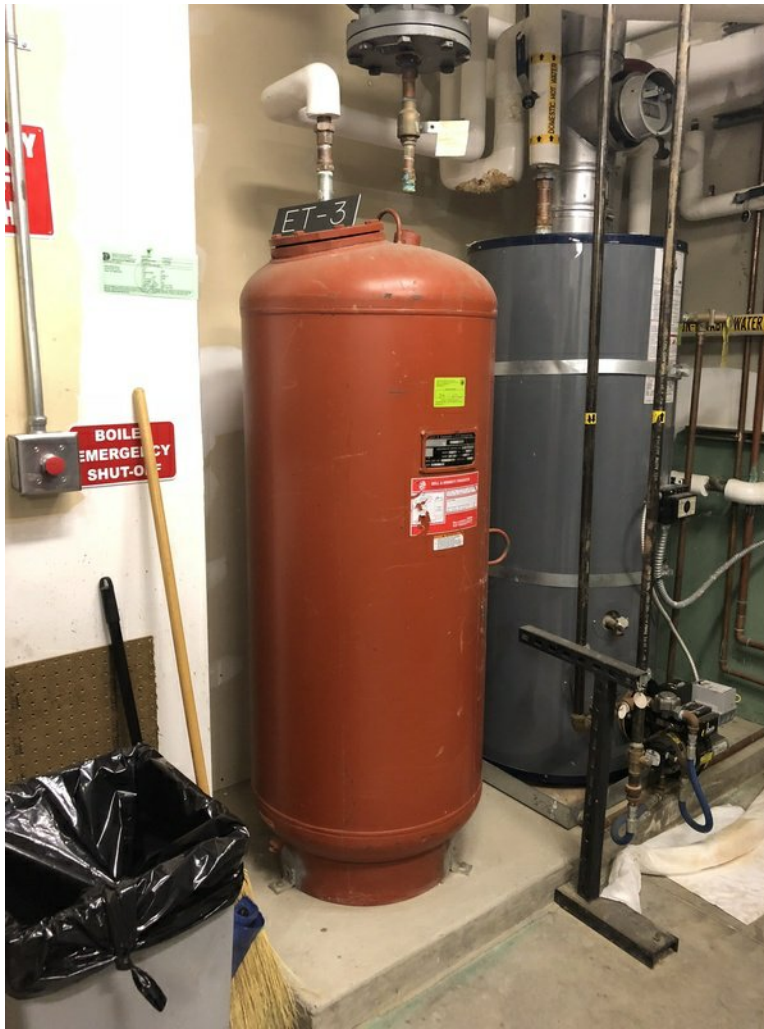
Figure 1-2. Unbraced Nonstructural Equipment

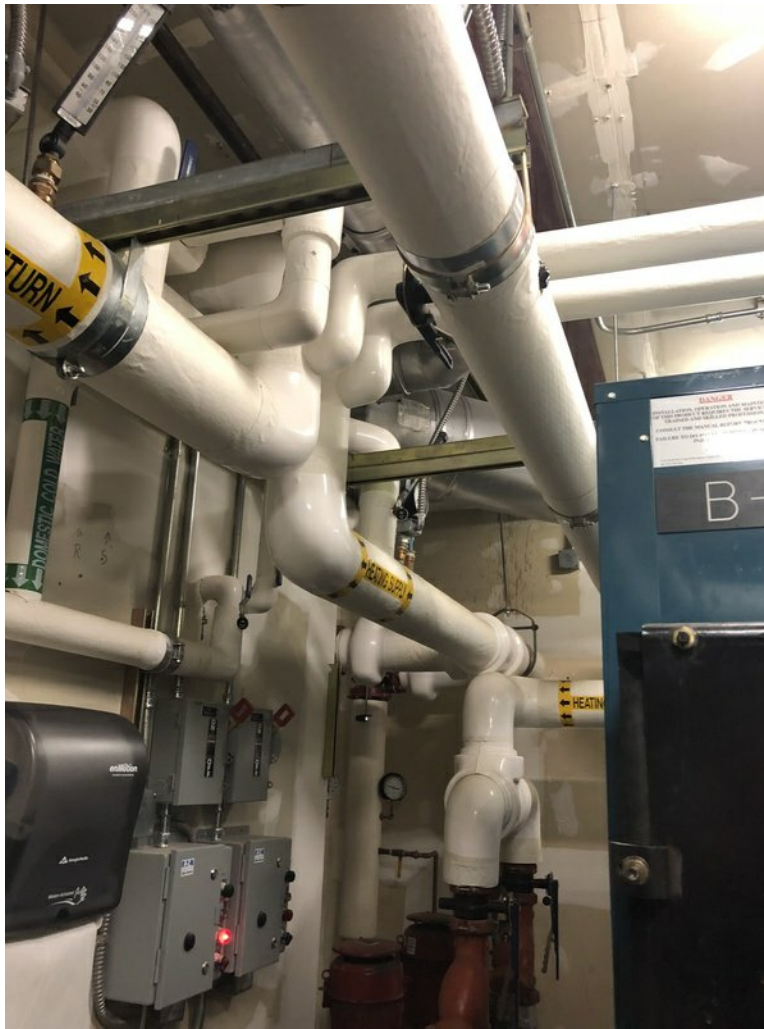
Figure 1-3. Unbraced Piping and Distribution Systems

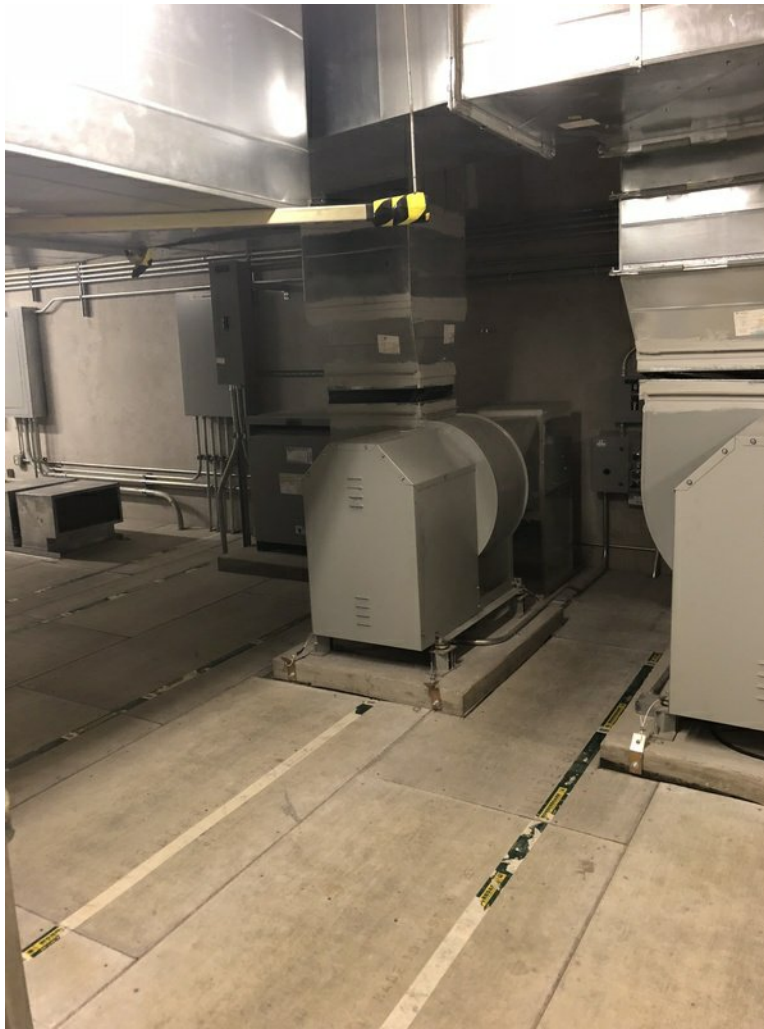
Figure 1-5. Anchored HVAC Equipment

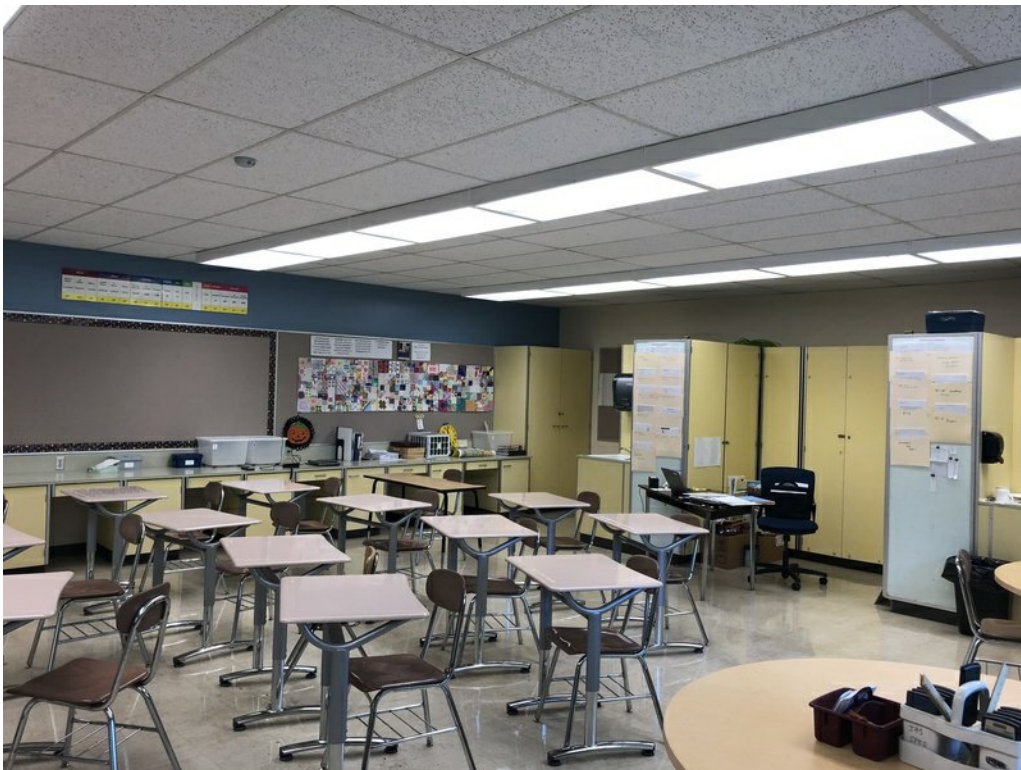
Figure 1-4. Typical Classroom with Tall Unbraced Cabinets

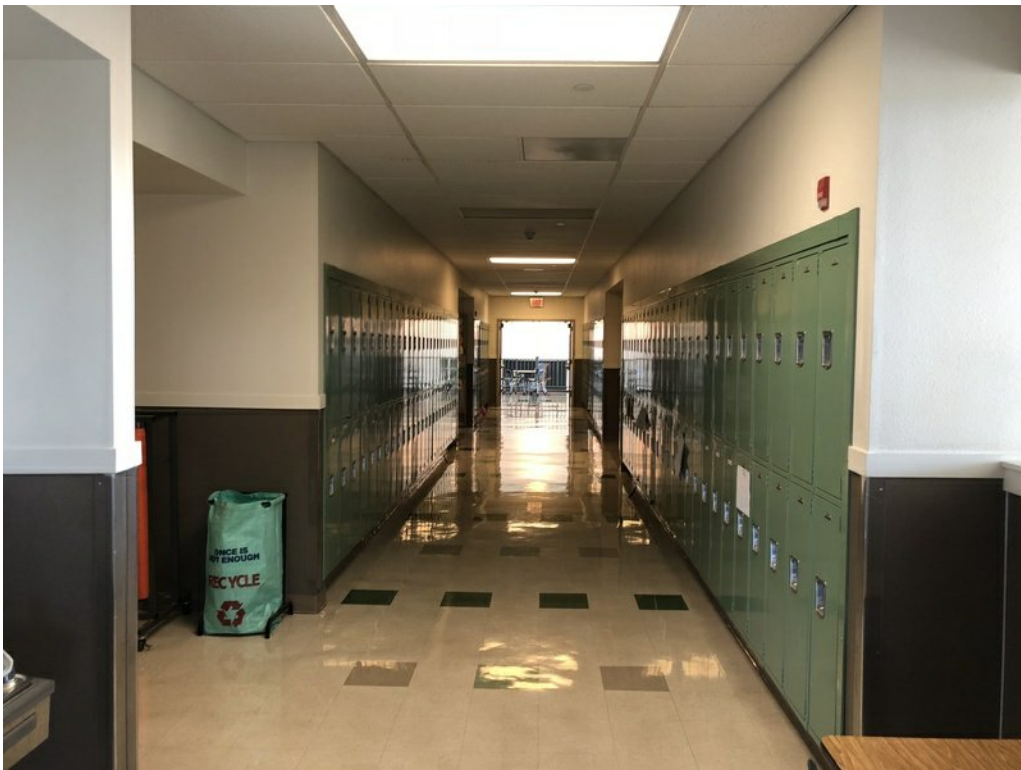
Figure 1-4. Typical Hallway with Unknown Light Fixture Bracing

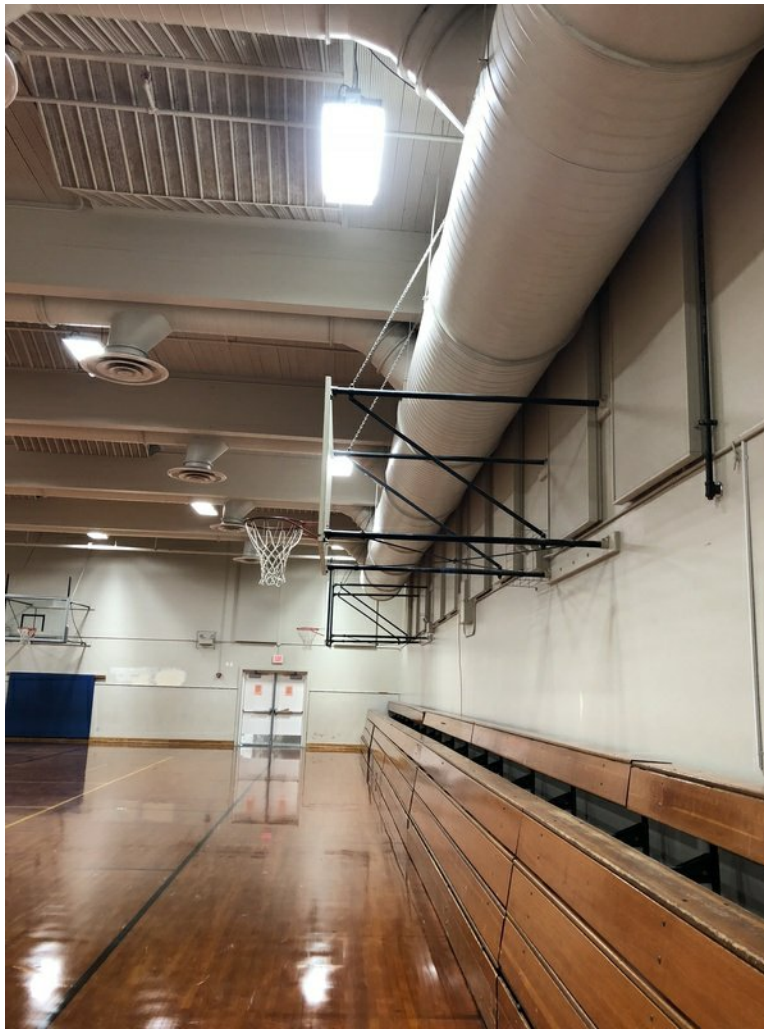
Figure 1-6. Gymnasium Showing Large Mechanical Ducts

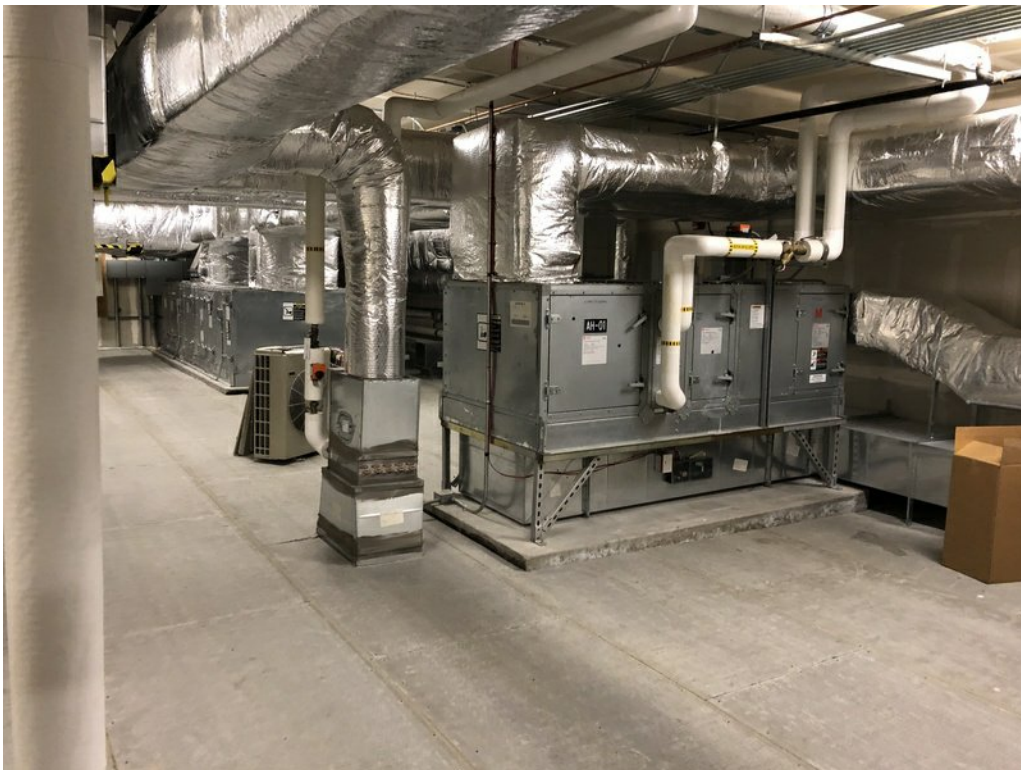
Figure 1-10. Mechanical Room

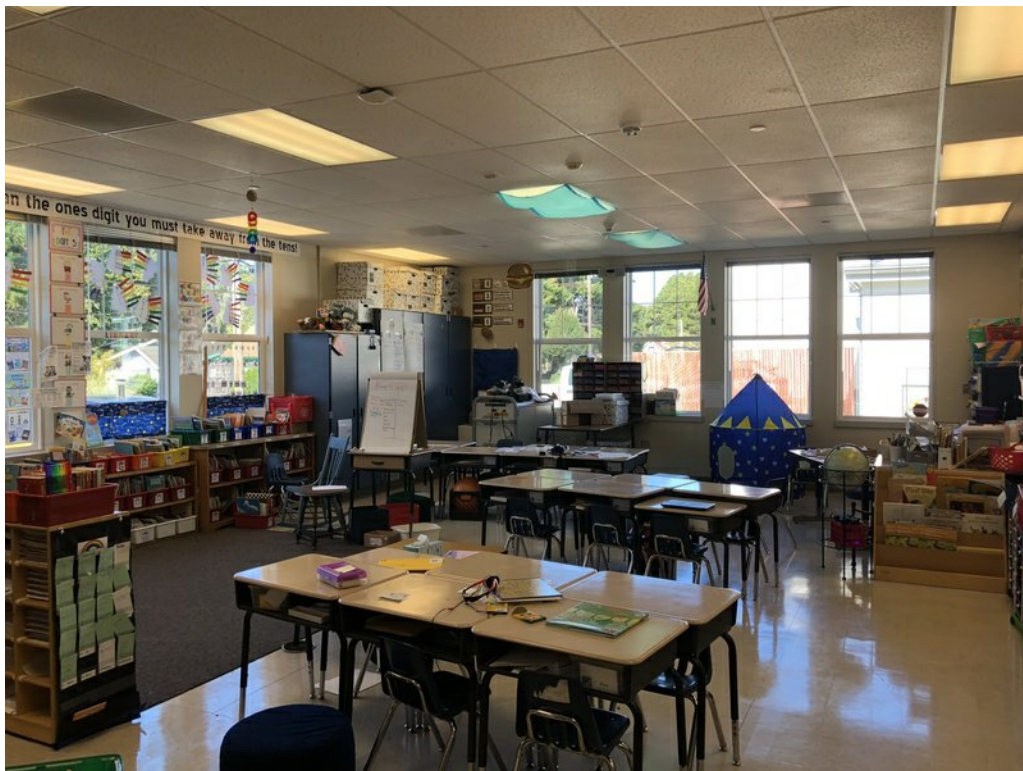
Figure 1-2. Classroom Space

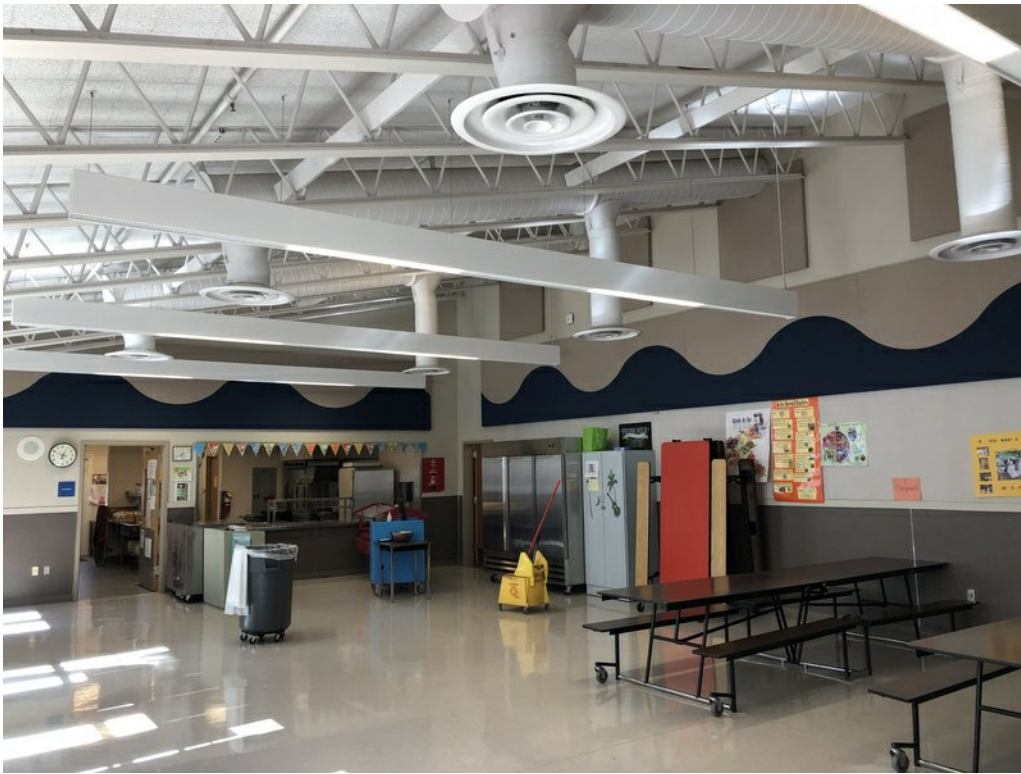
Figure 1-5. Open-Web Steel Joist Roof in Kitchen

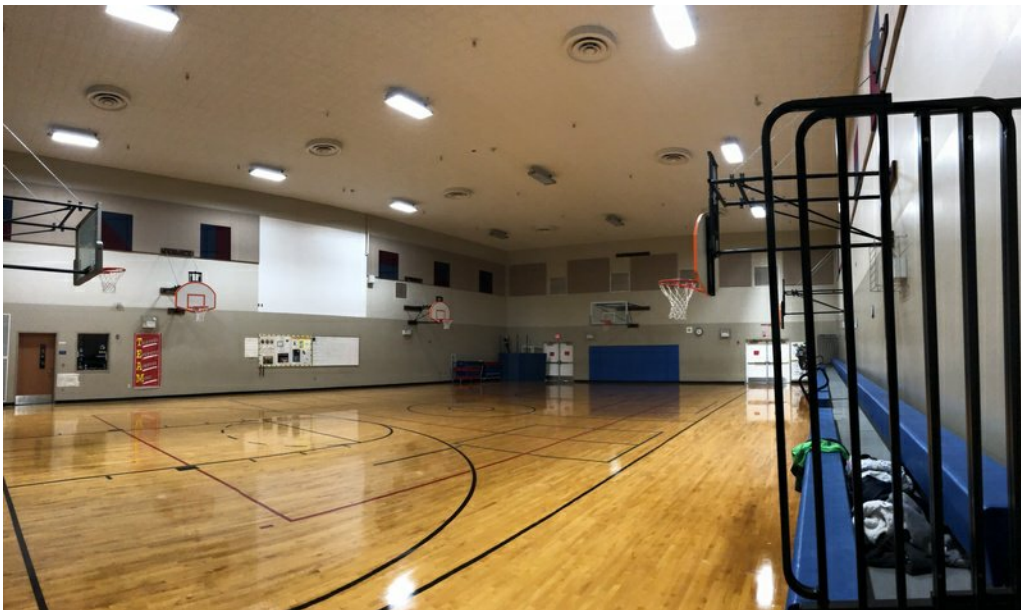
Figure 1-6. Gymnasium

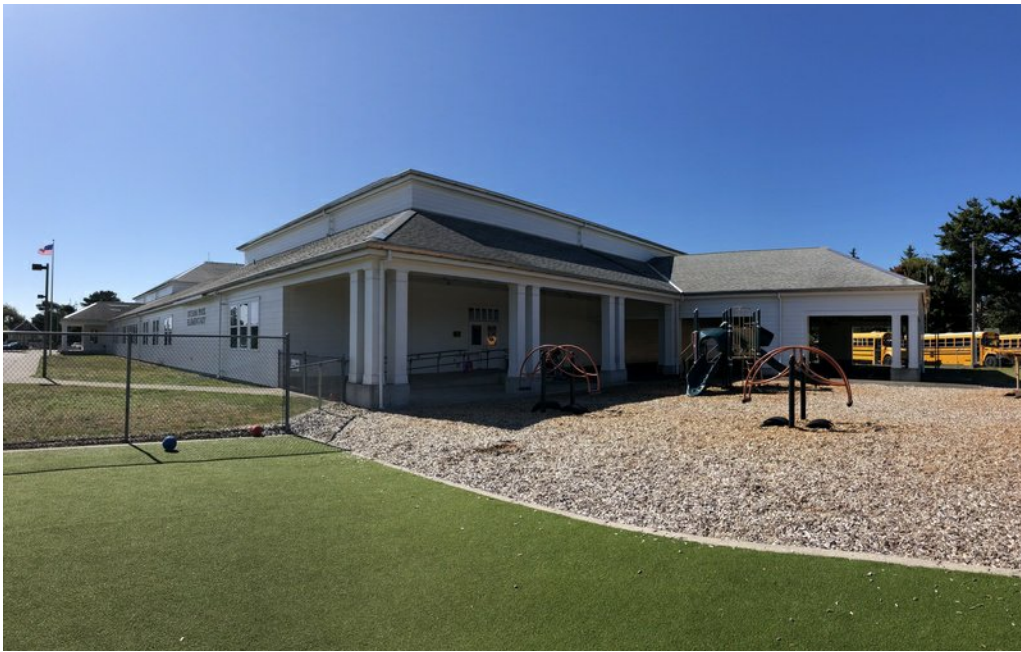
Figure 1-7. Ocean Park Elementary School - North Exterior

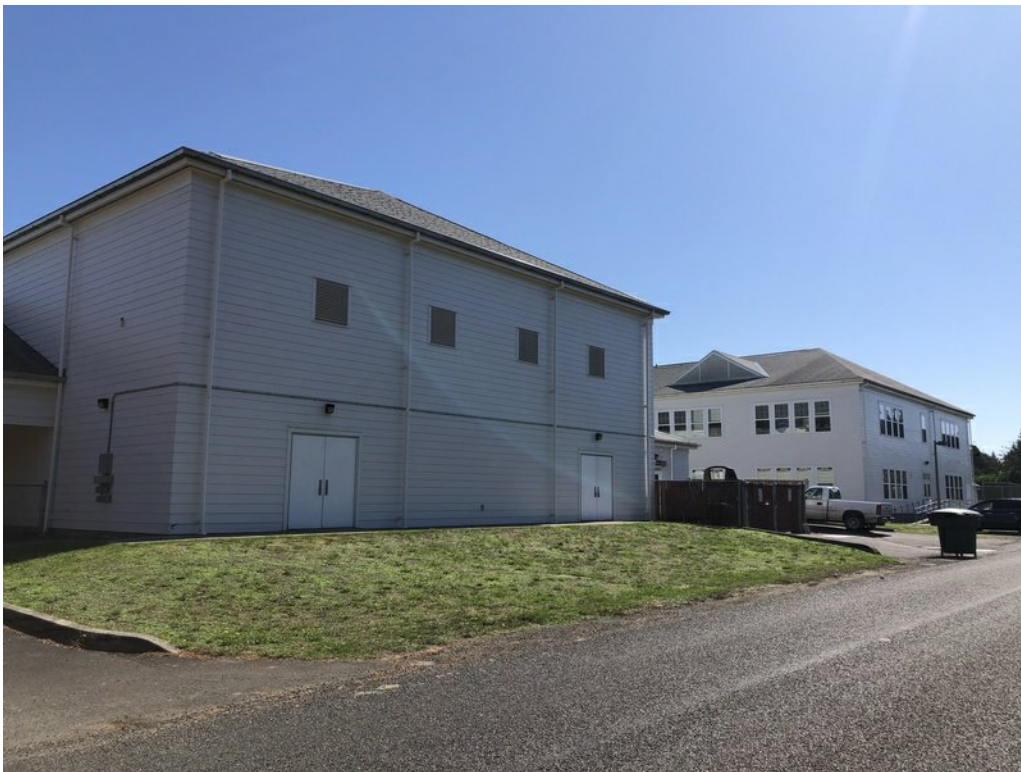
Figure 1-8. Ocean Park Elementary School - West Exterior

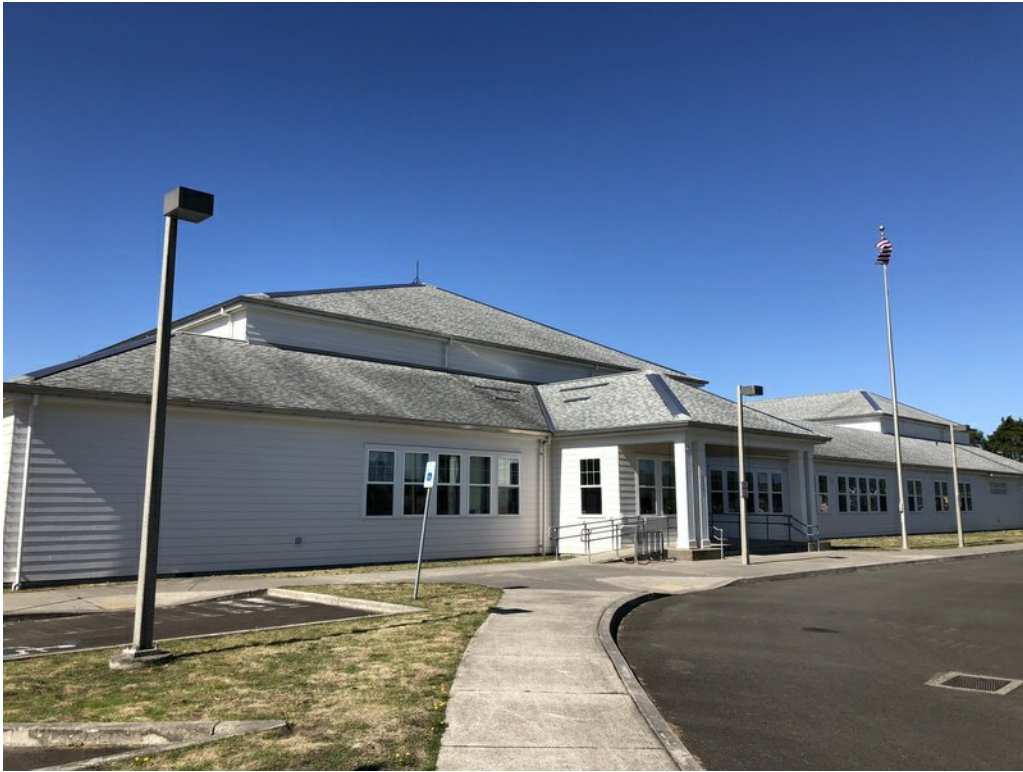
Figure 1-9. Ocean Park Elementary School - East Exterior

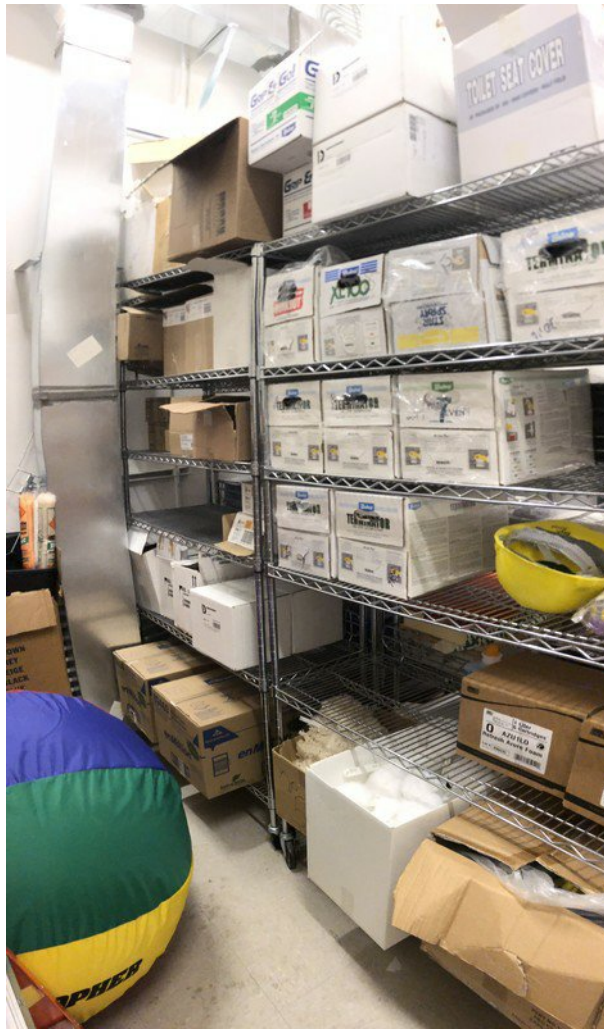
Figure 1-10. Unbraced Tall Narrow Contents, Typical Throughout
